PVC and CPVC Tru-Bloc® True Union Vented (Bleach) Ball Valve, Model D

The Chemtrol Solution

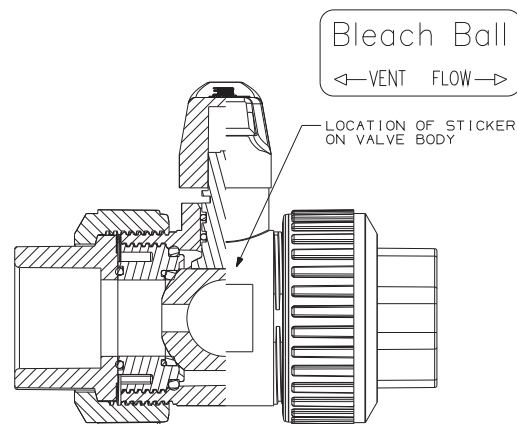
Permanent Bleach And Vent/Flow Directional Marking

Bleach Ball
← VENT FLOW →
LOCATION OF STICKER ON VALVE BODY

The Vented Ball Valve is a special factory modification to a PVC or CPVC True Union Ball Valve that effectively vents sodium hypochlorite out-gassing to the pressure port. In addition, the inner valve surfaces are kept constantly wetted to ensure problem-free use of the ball valves in bleach transfer and injection applications.

The Chemtrol® Vented Ball Valve offers a viable solution for sodium hypochlorite transfer and injection applications. Our unique factory-assembled bleach ball valve has effectively eliminated the problems associated with these uses. By ensuring that all inner surfaces of the valve are kept constantly wetted and vented to the upstream side when the valve is in the closed position, we have eliminated the conditions required for gas accumulation and caustic crystallization in the body cavity.
